## **Ideal Inspection**

## INSPECTION REPORT

Inspection: Magnetic Particle

Parts Examined: 7" ACT 65 Ton elevator

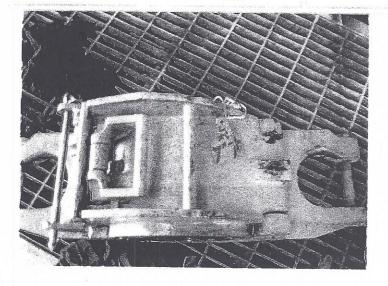
No defects found at time of inspection
